HOUSATONIC RIVER BASIN
HINSDALE, MASSACHUSETTS

BELMONT RESERVOIR DAM
MA 00224

PHASE I INSPECTION REPORT
NATIONAL DAM INSPECTION PROGRAM

MARCH 1980

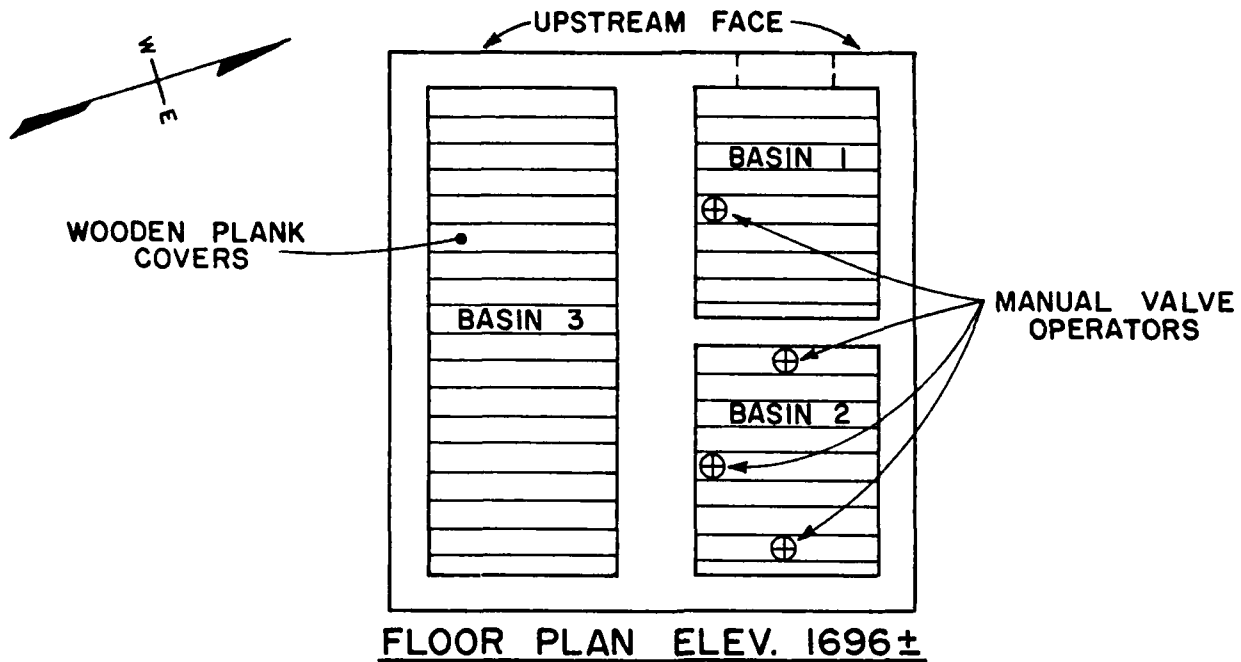
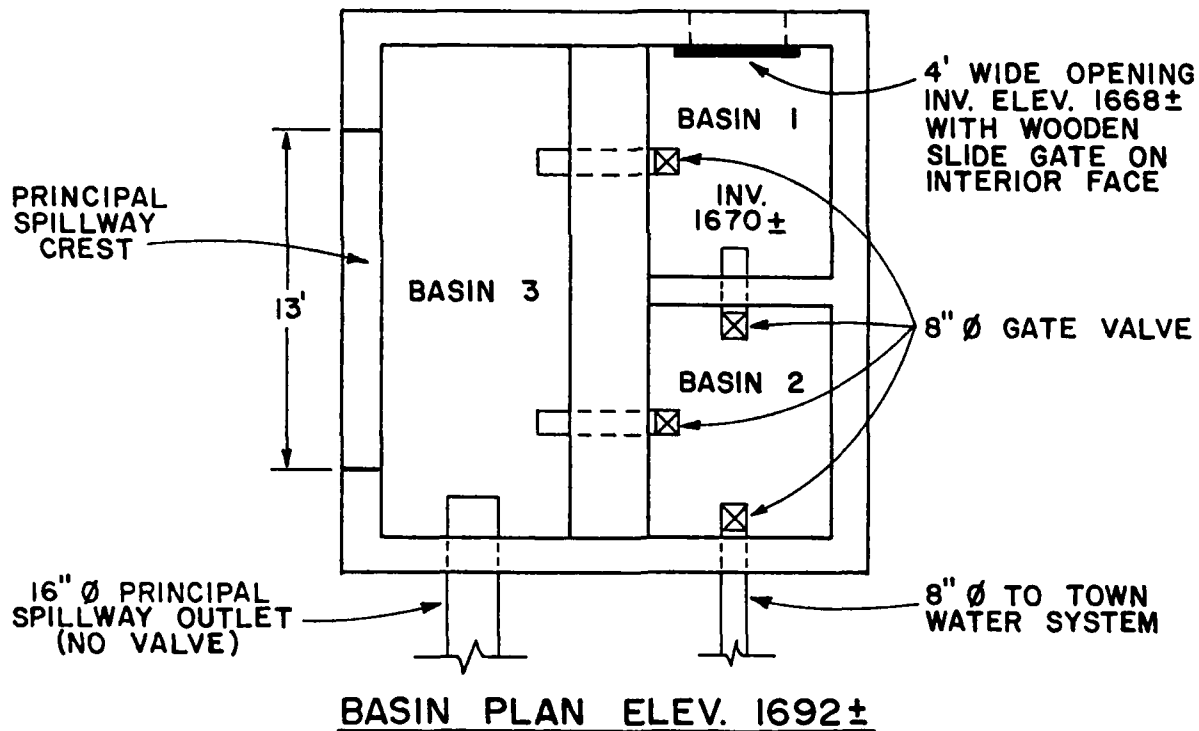
TIGHE & BOND / SCI CONSULTING ENGINEERS EASTHAMPTON, MASS.		U.S. ARMY ENGINEER DIV. NEW ENGLAND CORPS OF ENGINEERS WALTHAM, MASS.	
NATIONAL PROGRAM OF INSPECTION OF NON-FED. DAMS			
SKETCH OF GATE HOUSE			
BELMONT RESERVOIR DAM (MA 00224)		HINSDALE MASSACHUSETTS	
BERKSHIRE COUNTY		SCALE: NONE	
		DATE: MARCH 1980
